Vortex

Learn from the mistakes of others; you'll not live long enough to make them all yourself . . . **Issue 2/2002**

Early Lessons Learned

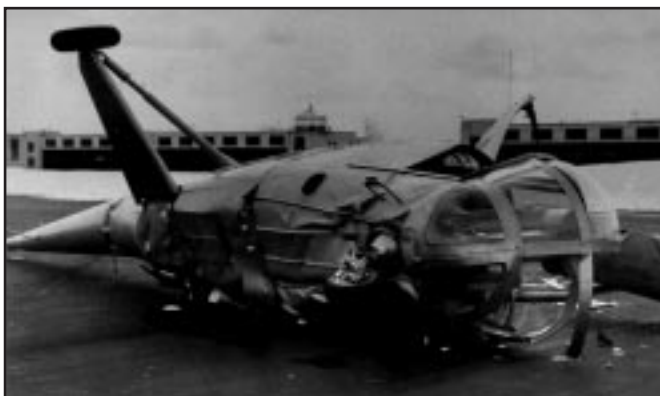
photo: Canadian Forces (RCAF)

The Royal Canadian Air Force were the first to import helicopters into Canada, and the first to suffer an accident with one. Flying Officer, Tom Wallnutt, obtained training during February, and flew the first Sikorsky S51, serial number 9601 into Canada on March 12, 1947. This was the first three S51s ordered for use in training and search and rescue roles. Wallnutt continued to build up flight time on the new helicopter at the Air Force Base in Trenton, Ontario. During one ‘touch and go’, while practicing autorotations on March 28, the wooden tail rotor brushed the runway. The pilot received no indication of this happening and opened the throttle to complete another circuit. At about 200 ft, the tail rotor splintered apart and the vibration tore the entire gearbox from the tail. The rotorcraft entered a violent spin and crashed on the runway. Wallnutt was thrown through the left side of the aircraft and onto the runway where he was struck by a main rotor blade. His flying suit and the aircraft wreckage were saturated with gasoline, but luckily there was no fire. Tom Wallnutt’s injuries kept him out of flying for nine months.

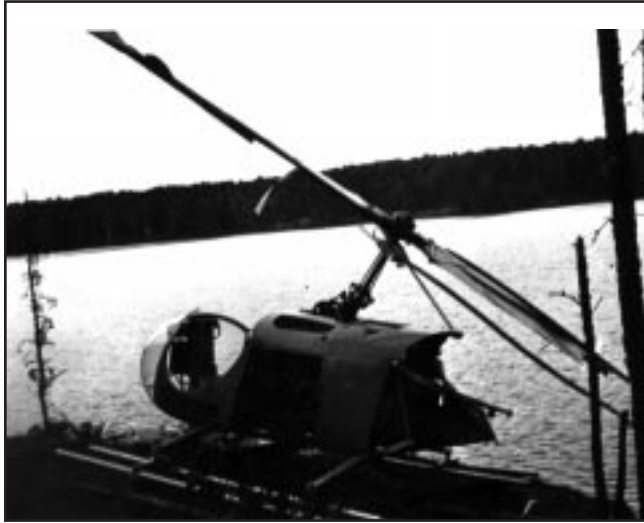
photo: Mr. Arthur Limmert

During mid June, Skyways Services flew CF-FQR from Winnipeg to the Kenora area in western Ontario to carry out timber cruising surveys with the Ontario Minnesota Pulp and Paper Company logging division. On June 19, 1947, pilot Paul Ostrander was flying between Red Lake and Fort Francis when the Franklin engine cylinder temperature gauge started to creep up into the hot range. Ostrander decided to set the float-equipped helicopter down on a small lake to check out the problem. As he approached the glassy water, the right float hit first, and the helicopter overturned into the lake. Ostrander and his passenger, Mr. N. Golder, were both able to release their seatbelts and exit the cabin safely. Paul’s entry in his logbook for June 19 indicated 5.45 hr of flight time and the remarks

“Crash—complete write-off—Hell Lake.” This was Canada’s first civilian helicopter accident.

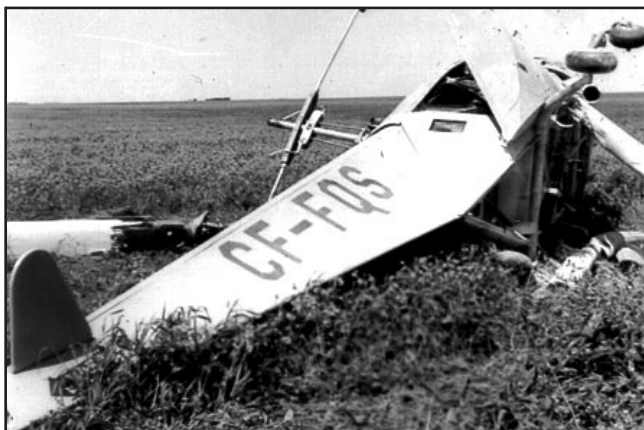
photo: Mrs. Betty Simpson

The second occurred in July 1947. Skyways Services chief pilot James Sampson had brought CF-FQS over to Regina, Saskatchewan, to carry out crop dusting on farms near the city. On July 13, he was busy spraying crops on Stan Walker’s farm, 18 mi. SW of Regina. During a dusting run along the edge of the field at about 4 to 6 ft above the ground, the main rotor struck a telephone pole and lost a one-foot section of blade. Sampson lost control of the helicopter due to the resulting severe vibration, and the rotorcraft struck the

ground. He was fortunate to emerge from the wreck unhurt. Skyway Services’ second helicopter was declared a write-off.

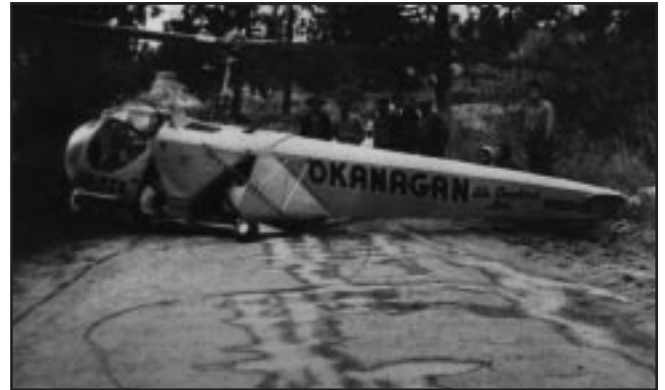
photo: Okanagan Helicopters Collection

CF-FZX, belonging to Okanagan Air Services, was involved in the third accident on September 12, 1947, near Kelowna, B.C. Carl Agar was spraying Andy Duncan Sr.’s orchard and during one pass, the helicopter came in contact with a power line. The aircraft settled onto the line, broke the two wires, and the helicopter impacted the ground. Agar was unhurt and managed to escape the damaged machine without

being electrocuted. The helicopter required major repairs in order to be flyable again, and was out of service until mid December.
